Panther Project Pictures

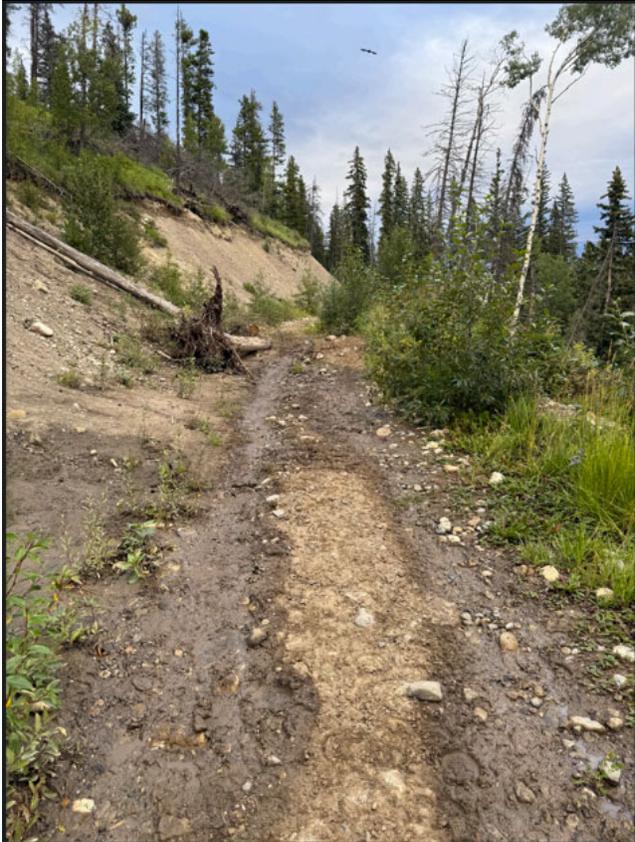
First Hill Climb - Before

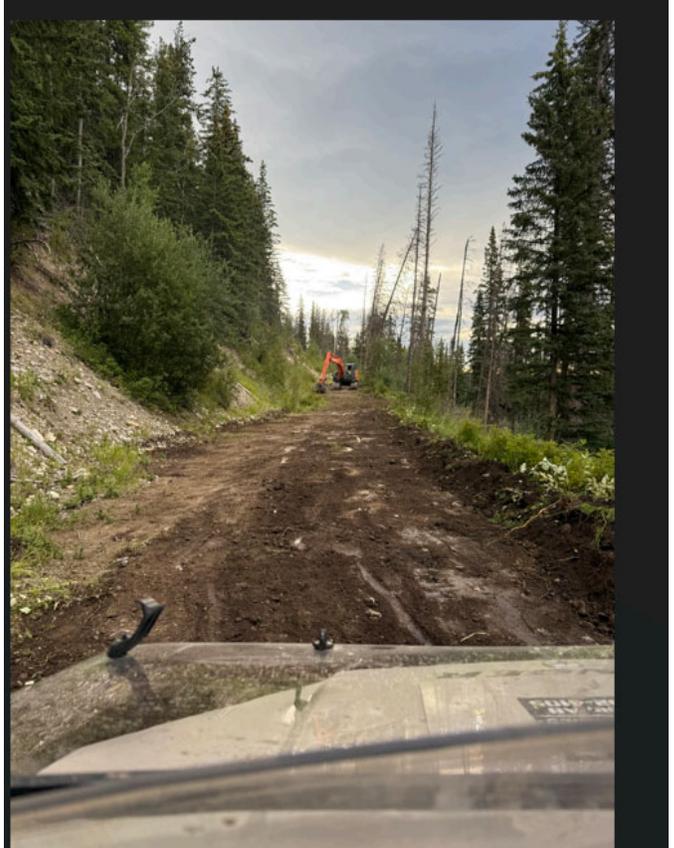
After

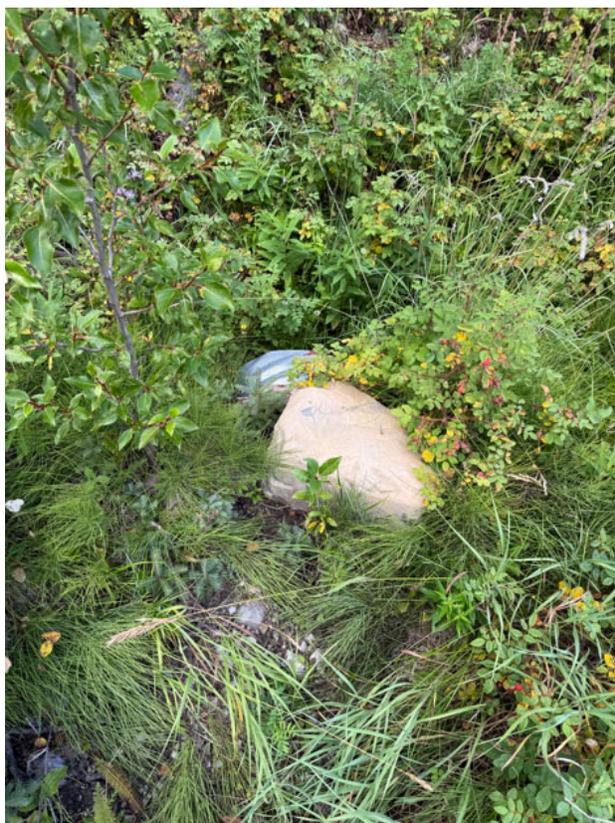
Example of plugged up culverts - Before

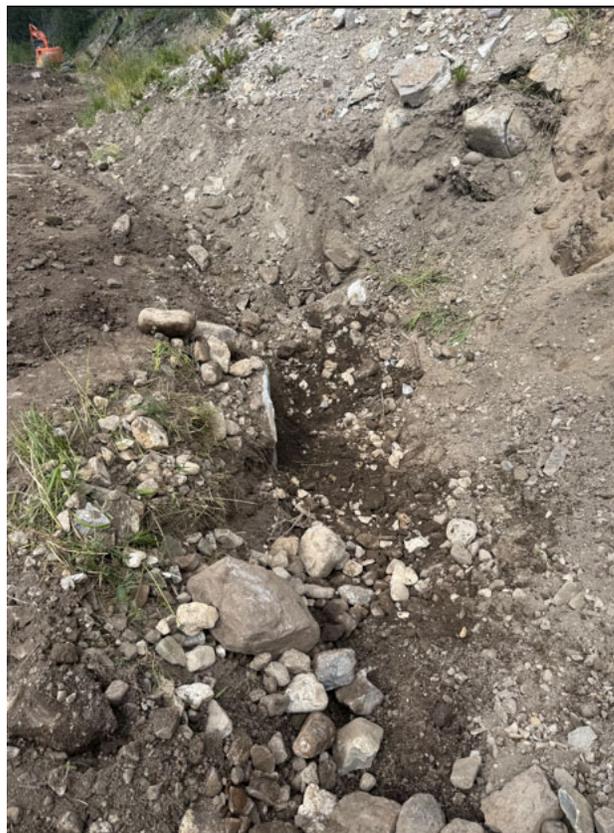
Photo on first hill climb, dug 3' down and back to find culvert

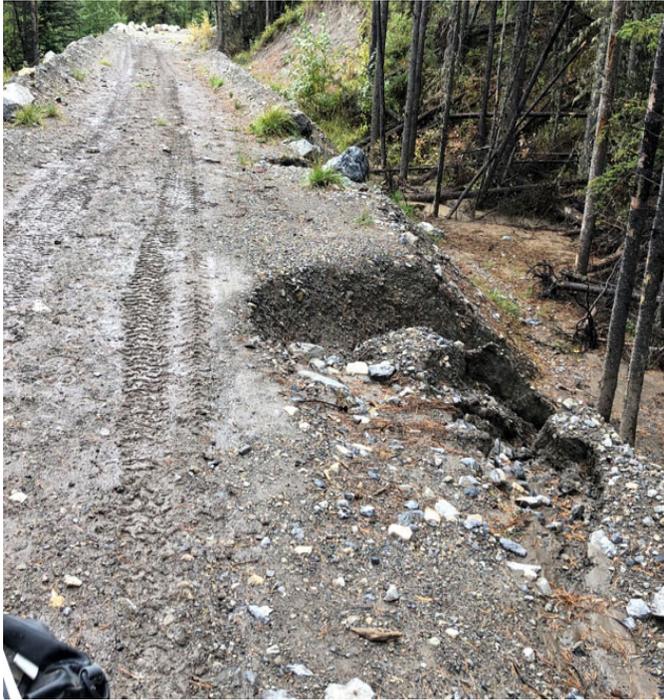
Sloughed in area where trail was under 6' wide
Before photo from 2020, trail condition worse in 2025

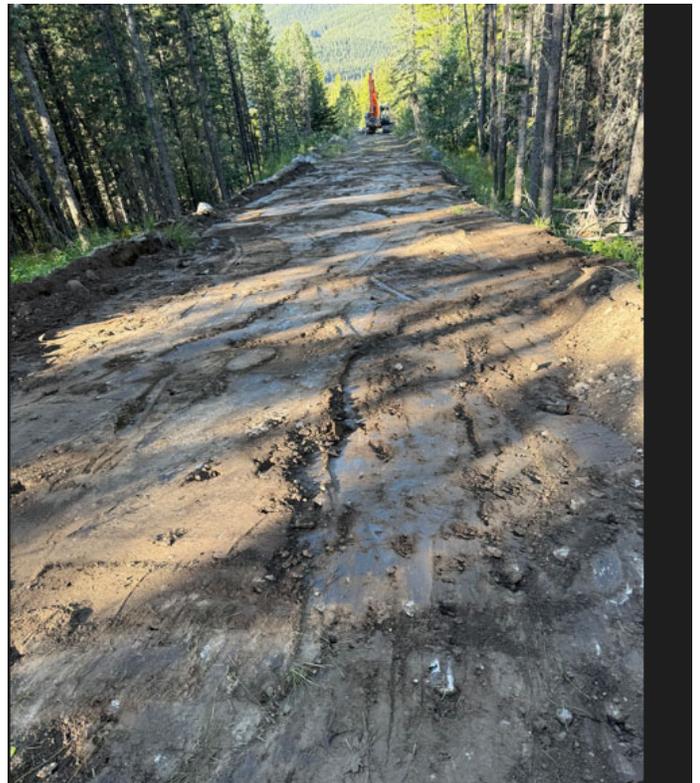
Trail width restored, culverts cleaned, and
erosion rocks placed around culverts

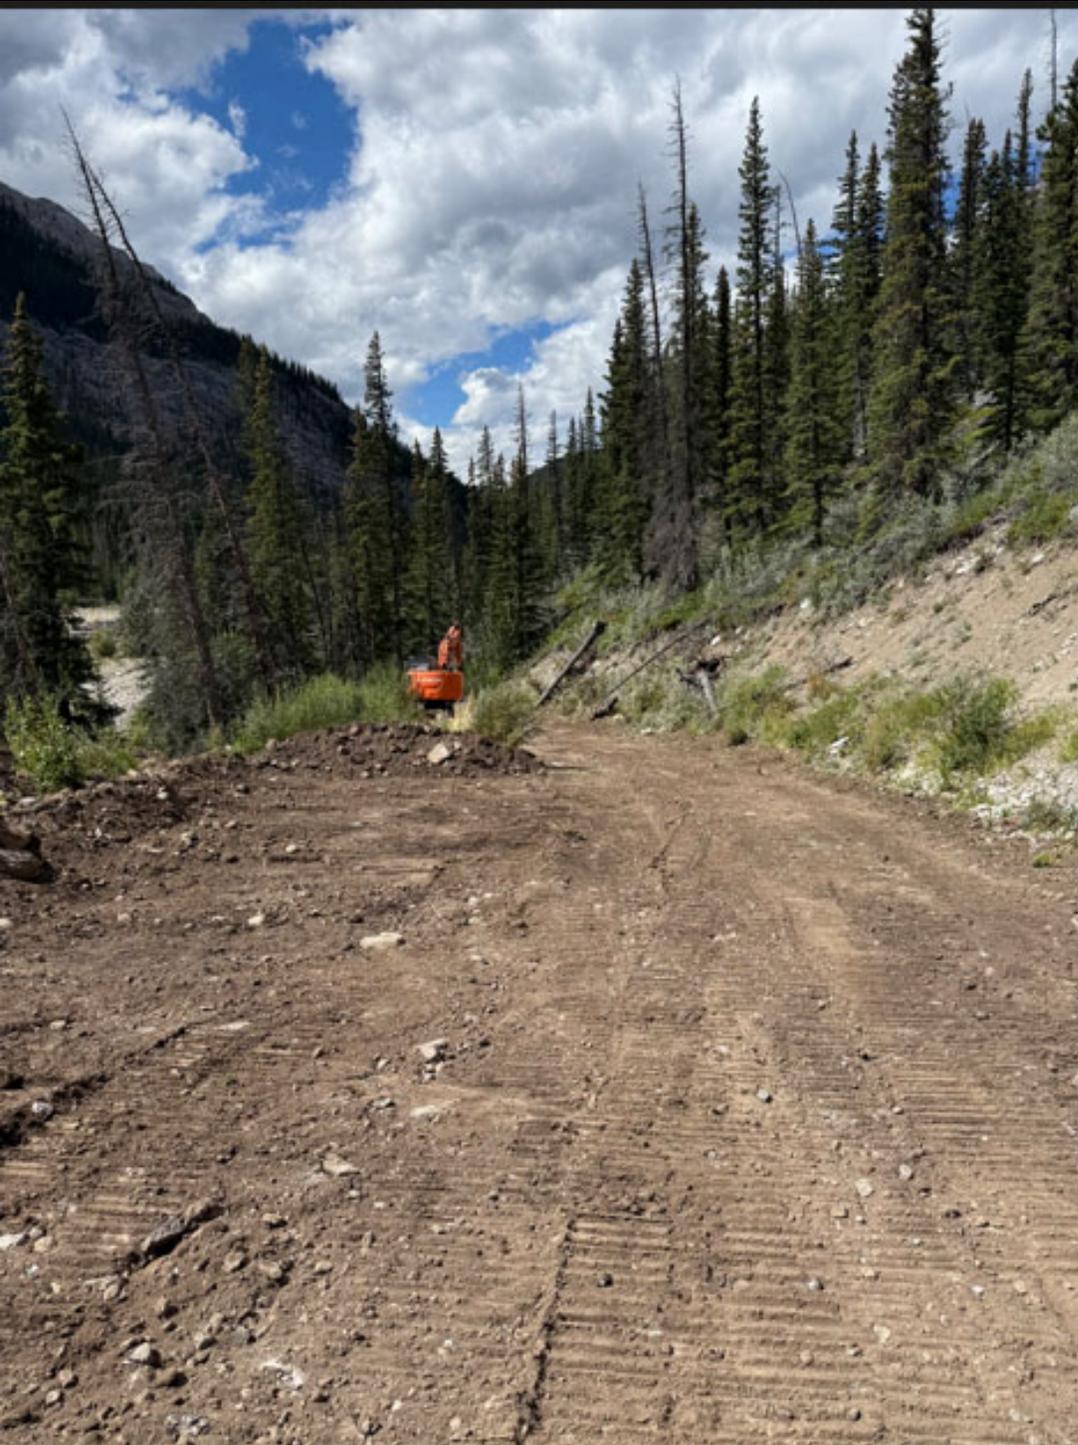
Trail was 2 different heights, leveled it and added a flat spot midway for wagons to take a break
